Home Inspection Report

Prepared for: Your Name

Prepared by: Dick Delaney Home Inspections
275 Pioneer Road
Franklin, PA 16323

08:54 April 12, 2008

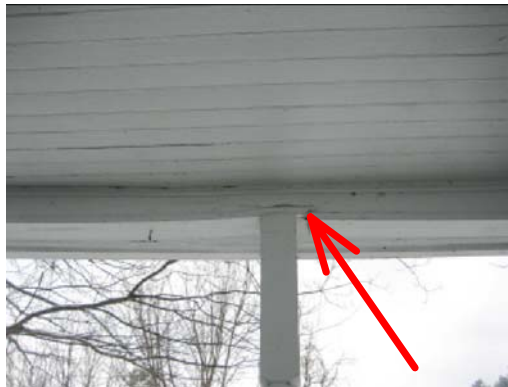
Porch: Wood -Water damage noted, A qualified contractor is recommended to evaluate and estimate repairs

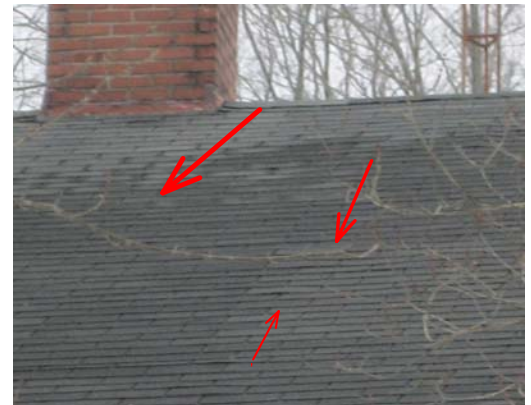
| 2. Repair or replace | Material: Composition Shingle

-Loose or damaged shingles,
Moisture noted in the attic,
Evaluation by a qualified
roofing contractor is
recommended |

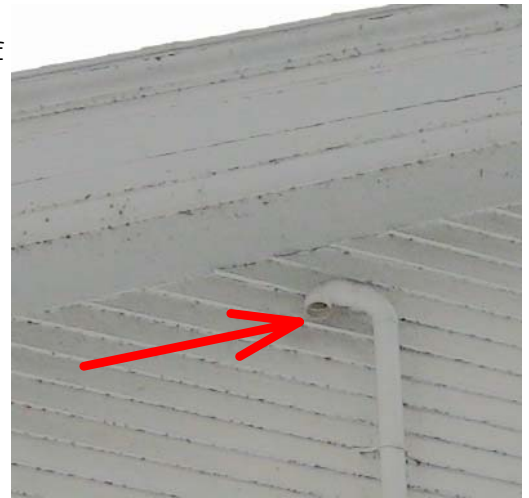
Plumbing Vents: PVC -All vent pipes should extend above the eaves of the roof

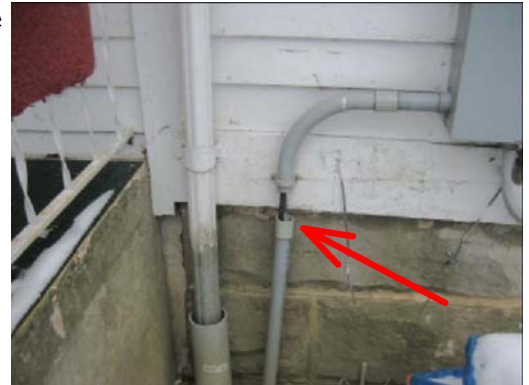
Electrical Mast: Surface mount -Loose conduit

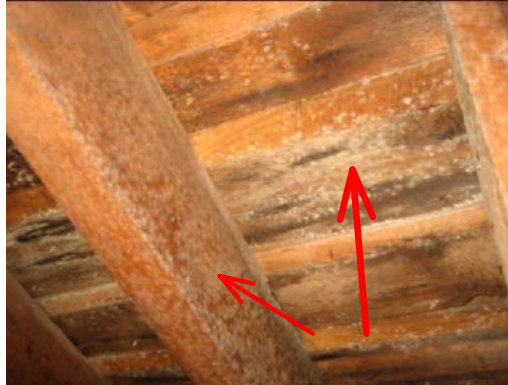
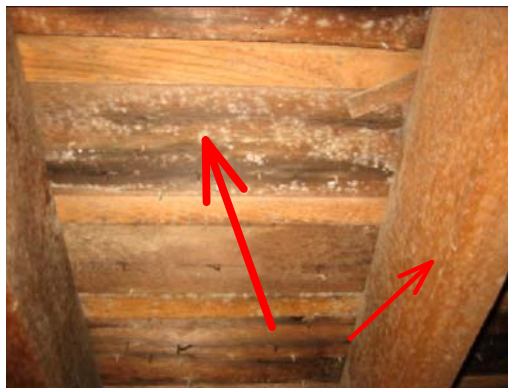
Sheathing: Dimensional wood -Possible mold noted, Recommend professional testing

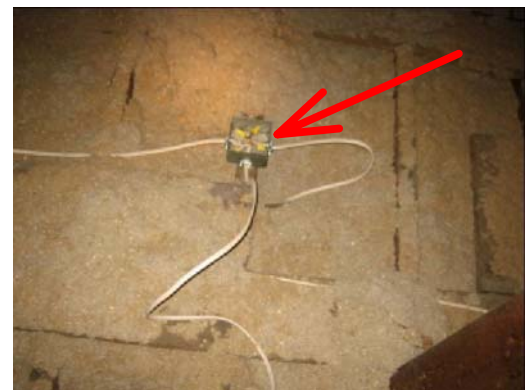
Wiring/Lighting: 110 VAC -Open junction box

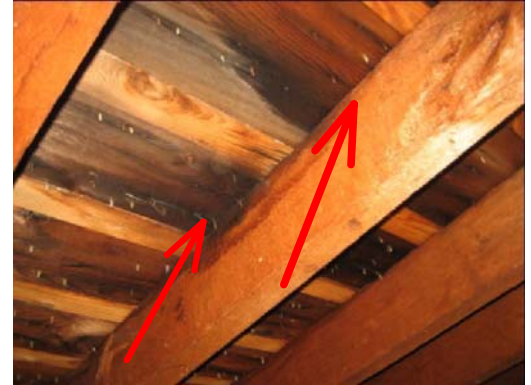
- 11. Serviceable
 - 12. Serviceable
 - 13. Serviceable
 - 14. Repair or replace
- Sheathing: Dimensional wood
Insulation: Blown in
Insulation Depth: 6 "
Moisture Penetration: Ongoing water penetration noted -A qualified roofing contractor is recommended to evaluate and estimate the cost of repair

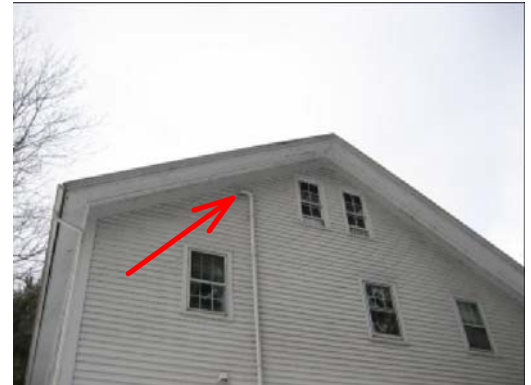
5. Maintenance Vent Pipes: PVC -The vent pipe terminates improperly, All vent pipes should extend above the eaves

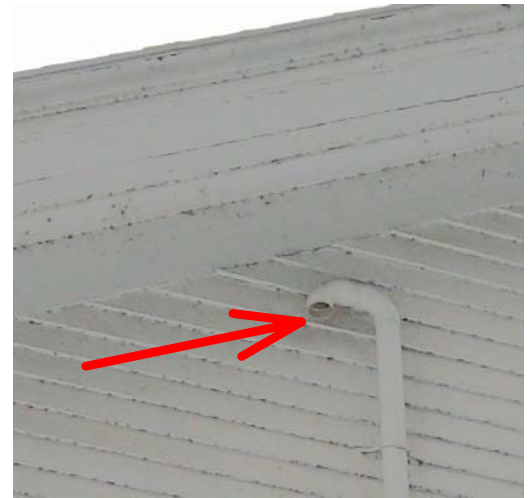
1. Plumbing Vents: PVC -All vent pipes should extend above the eaves of the roof

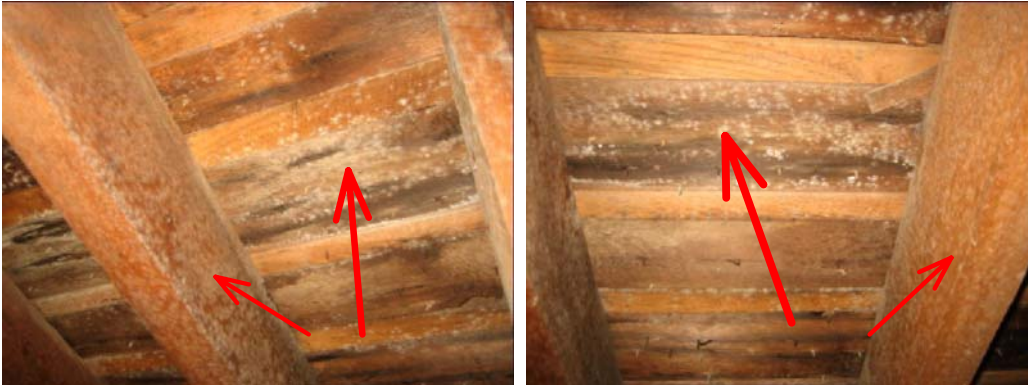
3. North Attic Sheathing: Dimensional wood -Possible mold noted, Recommend professional testing

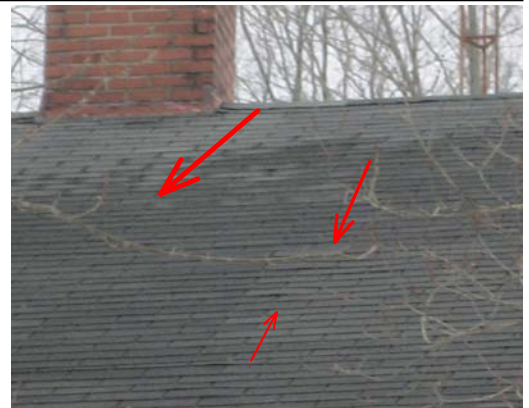
2. Main Roof Surface Material: Composition Shingle -Loose or damaged shingles, Moisture noted in the attic, Evaluation by a qualified roofing contractor is recommended

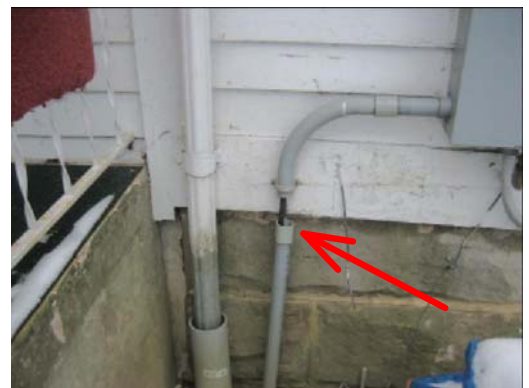
3. Electrical Mast: Surface mount -Loose conduit

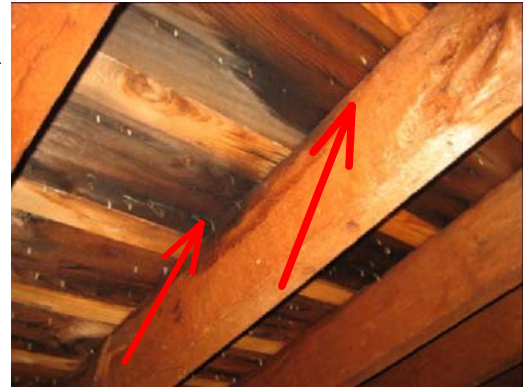
4. South Attic Moisture Penetration: Ongoing water penetration noted -A qualified roofing contractor is recommended to evaluate and estimate the cost of repair
