Home Inspection Report

Prepared for: Your Name

Prepared by: Dick Delaney Home Inspections
275 Pioneer Road
Franklin, PA 16323

08:54 April 12, 2008

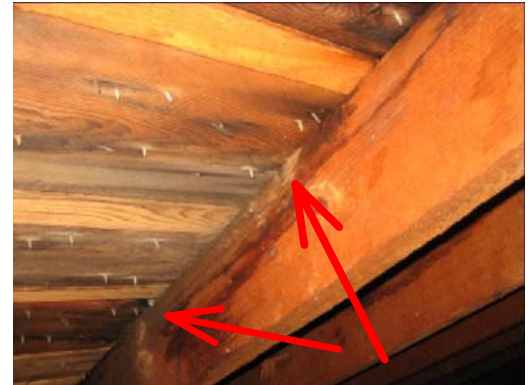
- 11. Serviceable
 - 12. Serviceable
 - 13. Serviceable
 - 14. Repair or replace
- Sheathing: Dimensional wood
Insulation: Blown in
Insulation Depth: 6 "
Moisture Penetration: Ongoing water penetration noted -A qualified roofing contractor is recommended to evaluate and estimate the cost of repair
